Lenovo ThinkSystem NE2572 RackSwitch

Release Notes

For Lenovo Cloud Network Operating System 10.9

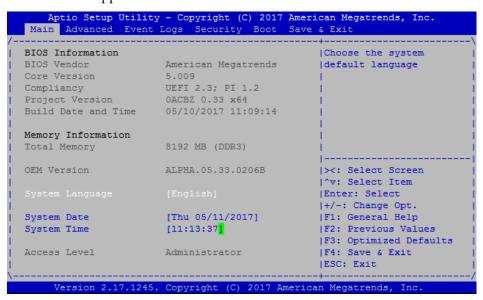
The BIOS menu appears.

This menu permits the following actions:

- Monitoring system configuration
- Setting user passwords
- Switching to Secure Boot Mode
- Performing key provisioning
