Lenovo RackSwitch G8296

Release Notes

For Lenovo Cloud Network Operating System 10.9

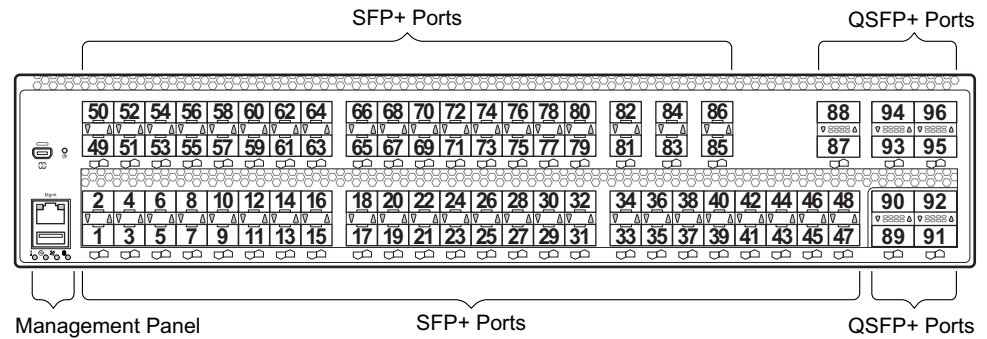
Figure 1. G8296 front panel

- Eighty-six 10 Gigabit Ethernet (GbE) Small Form Pluggable Plus (SFP+) ports which also support legacy 1 GbE connections
- Ten 40 GbE Quad Small Form Pluggable Plus (QSFP+) ports, two of which (Ethernet 1/87 and Ethernet 1/88) can optionally be used as four 10 GbE SFP+ ports
