Lenovo RackSwitch G8332

Release Notes

For Lenovo Cloud Network Operating System 10.10

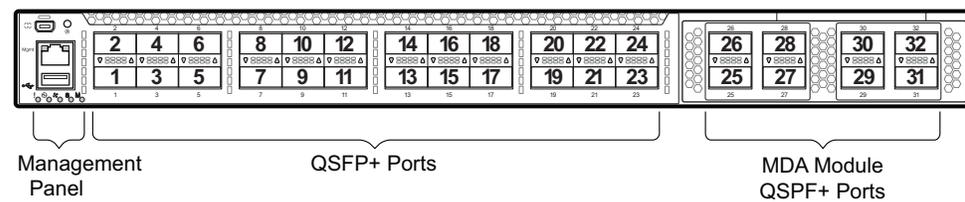
Figure 1. G8332 front panel

- Twenty-four 40 Gigabit Ethernet (GbE) Quad Small Form Pluggable Plus (QSFP+) ports, each of which can optionally be used as four 10 GbE Small Form Pluggable Plus (SFP+) ports
- Eight additional 40 GbE QSFP+ ports through the Media Dependent Adapter (MDA) module
