Lenovo ThinkSystem NE2572 RackSwitch

Release Notes

For Lenovo Cloud Network Operating System 10.9

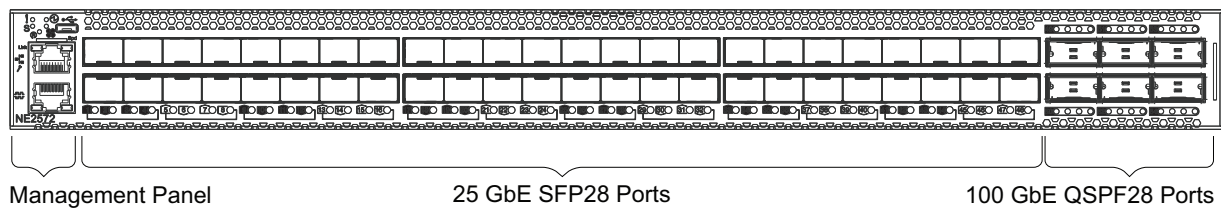
- Forty-eight 25 GbE Small Form Pluggable 28 (SFP28) ports
- Six 100 GbE Quad Small Form Pluggable 28 (QSFP28) ports - each QSFP28 port can optionally be used as four 25 GbE SFP+ ports

Figure 1. NE2572 front panel
